**Moose Creek Steelhead Habitat Improvement Project**  
**Project Completion Report**  
**OWEB #208-3057-6374**  
**Prepared by: The South Santiam Watershed Council**  
**September 2011**

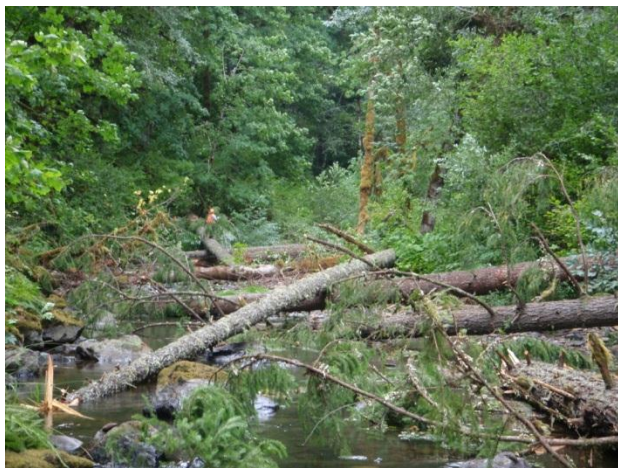
*Placing logs with helicopter, August 2008*

creek and capturing other logs as they are mobilized in high water events. Once the trees were pulled into the creek, a total of 41 full-length trees (140’-170’ in length with a dbh of 28”-36”) were placed with a Chinook helicopter in three areas of Moose Creek that correspond to the cross-sections on the attached map. The flight time (and cost) for the helicopter was lower than anticipated due to the staging of logs close to the placement areas in the creek. This savings allowed for further restoration actions to take place that supplemented and improved upon the original proposal.

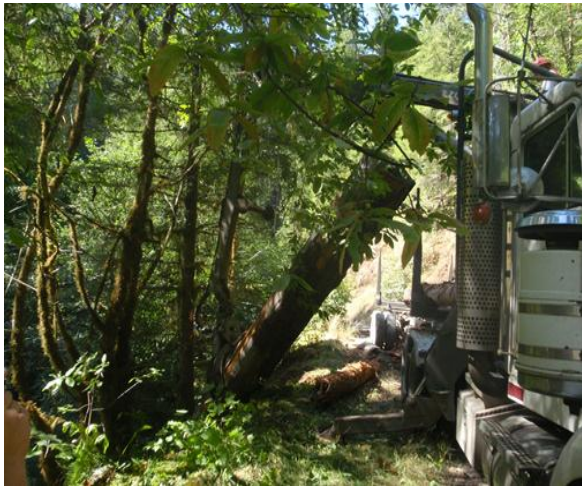
*Self-loader placing logs, August 2011*

In August, 2011 the project partners were able to secure ~40 logs from the U.S. Army Corps of Engineers which had stockpiled logs near Green Peter and Foster Reservoirs. The logs were of varying length and diameter, with an estimated average of 30' x 28". 14 of the logs included rootwads. The logs were moved and placed with a self-loader at two locations near the upper end of the project area. It is expected that these logs will mobilize in high water and float into downstream channel spanning log jams. With these additions, the total number of project logs is over 100.
